**Flood Control Project Maintenance  
Levee Inspections**

## Maintenance Issue Types Only, Levee Inspection Report By Mile - Spring 2017

### Reclamation District No. 2089 Stark

Waterway	Bank	Unit Miles	Inspection Start/End	Inspector
Unit No. 01 Old River	Right	1.51	04/12/2017 04/12/2017	Maksim Khashchuk

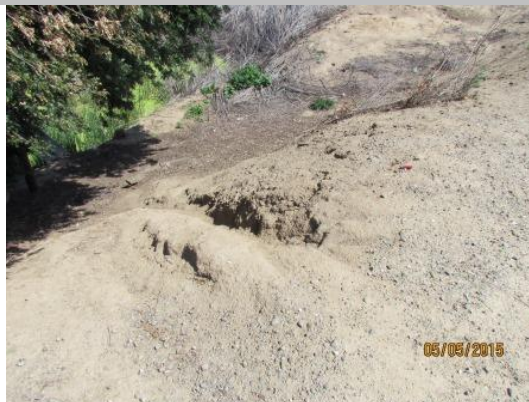
Photo 1 of 1 : SP\_2017\_RD2089\_316\_1\_20170407\_00001.jpg

LM Start	<b>0.03</b>	Rating **	M	Issue No.	<b>1</b>
LM End	<b>0.03</b>	Issue Type +	Ma	Location *	LS
Category	Earthen Levee		GPS Latitude/Longitude		
			Start	End	
Item	Encroachments		37.811508 °	37.811508 °	
			-121.385464 °	-121.385464 °	
DWR ID	DWR_RD2089_01_s_2012_1				
Comment Code					
ST : Stairway					
Inspector Comment					
Steps have been cut into the levee slope, this could become an erosion point, please fill and compact.

View of the stairs eroding into the landside levee slope.

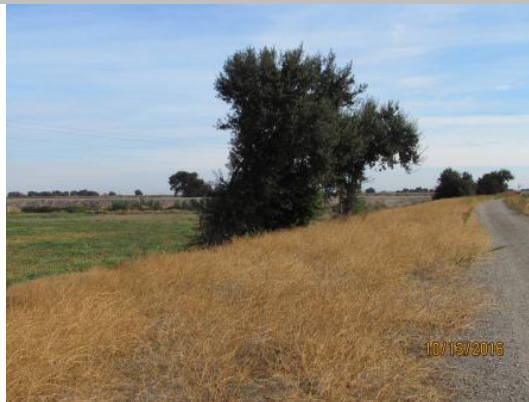
Photo 1 of 1 : SP\_2017\_RD2089\_316\_30\_20170407\_00022.jpg

LM Start	<b>0.04</b>	Rating **	M	Issue No.	<b>30</b>
LM End	<b>0.24</b>	Issue Type +	Ma	Location *	LS
Category	Earthen Levee		GPS Latitude/Longitude		
			Start	End	
Item	Vegetation		37.811474 °	37.810451 °	
			-121.385573 °	-121.389109 °	
DWR ID	DWR_RD2089_01_f_2016_30				
Comment Code					
V1 : Control annual grass and weeds on the levee slopes and easements.					
Inspector Comment

View of the vegetation on the landside levee slope.

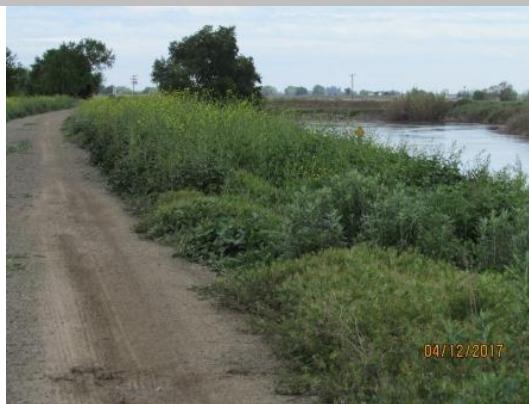
Photo 1 of 1 : SP\_2017\_RD2089\_316\_35\_20170417\_00054.jpg

View of the tall vegetation on the levee slope.

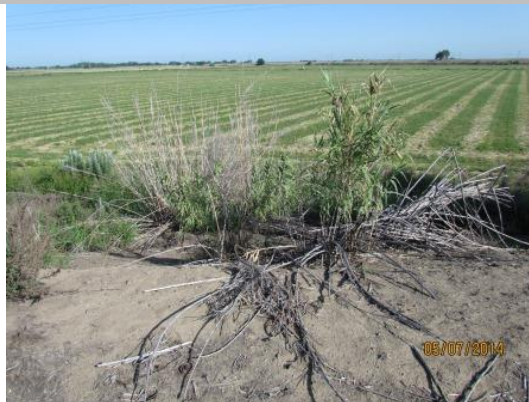
Photo 1 of 1 : SP\_2017\_RD2089\_316\_940\_20170407\_00030.jpg

LM Start	0.24	Rating **	A/W	Issue No.	940
LM End	0.24	Issue Type +	Ma	Location *	LS
Category	Earthen Levee			GPS Latitude/Longitude	
				Start	End
Item	Vegetation			37.810412 °	37.810412 °
				-121.389115 °	-121.389115 °
DWR ID	DWR_RD2089_01_s_2012_940				
Comment Code					
V2 : Remove the wild growth other than native grasses from the levee slopes.					
Inspector Comment					
Arundo has been trimmed back from the crown but still remains as an obstruction to the slope and obstructs visibility, needs to be removed.

The LMA is actively trying to remove the vegetation on the landside levee slope and toe.

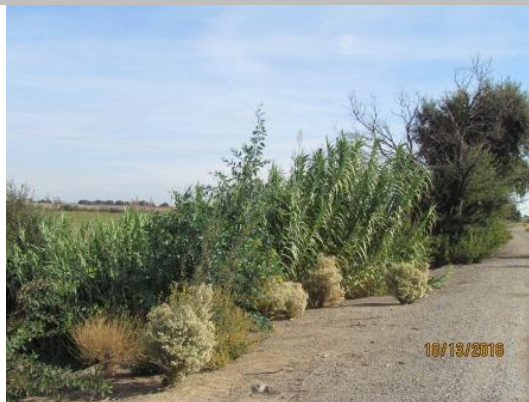
Photo 1 of 2 : SP\_2017\_RD2089\_316\_19\_20170407\_00012.jpg

View of the arundo back on the landside levee slope. Fall 2016

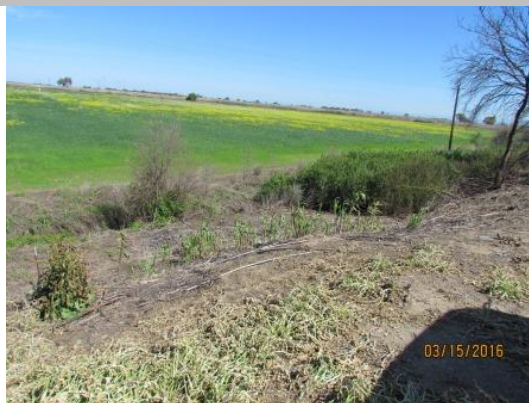
Photo 2 of 2 : SP\_2017\_RD2089\_316\_19\_20170407\_00013.jpg

Arundo was trimmed back from the road and needs to be maintained so that it does not obstruct visibility and access to the landside toe.

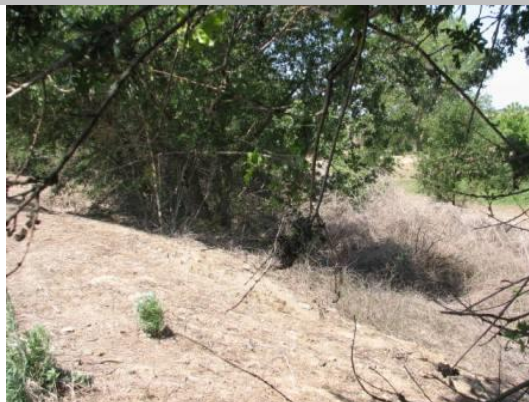
Photo 1 of 1 : SP\_2017\_RD2089\_316\_28\_20170407\_00020.jpg

LM Start	0.41	Rating **	M	Issue No.	28
LM End	0.46	Issue Type +	Ma	Location *	LS
Category	Earthen Levee			GPS Latitude/Longitude	
				Start	End
Item	Vegetation			37.809593 °	37.809507 °
				-121.391963 °	-121.392907 °
DWR ID	DWR_RD2089_01_s_2012_28				
Comment Code					
V2 : Remove the wild growth other than native grasses from the levee slopes.					
Inspector Comment					
Vegetation is too thick to allow access and visibility. Some thick patches of shrubs remain and continue to block visibility and access.

05/24/2011 Photo shows thick dead vegetation and continuation of trees in area that are preventing access and visibility of landside slope and toe.

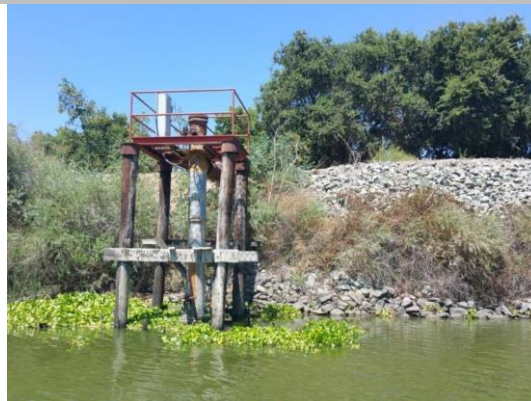
Photo 1 of 2 : SP\_2017\_RD2089\_316\_5\_20170407\_00005.jpg

LM Start	0.46	Rating **	M	Issue No.	5
LM End	0.46	Issue Type +	Ma	Location *	WS
Category	Supplemental			GPS Latitude/Longitude	
				Start	End
Item	DWR Erosion Survey			37.809394 °	37.809394 °
				-121.392791 °	-121.392791 °
DWR ID	DWR_RD2089_01_s_2017_5				
Comment Code					
Inspector Comment					
07/25/2016: No significant change observed.					
06/25/2015: No significant change observed.					
07/02/2014: No significant change observed.					
08/13/2013: No significant change observed.					
08/07/2012: The site has been visited by boat survey. No significant change observed					
08/23/2011: The site shows loose material around the pipe crossing.					
The operation of the pipe might have caused an impact on the levee.					
[2016 Site ID:RD2089U01RM29.8]

Front view of the site. Note the irrigation pipe on the site.

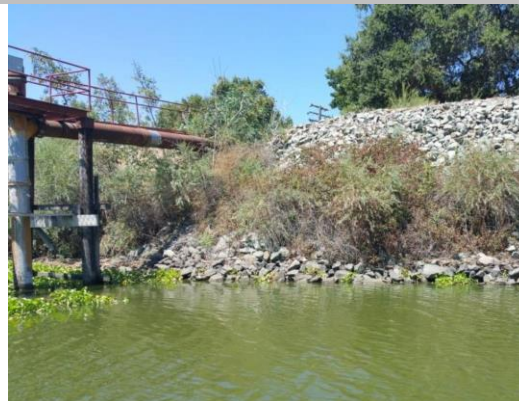
Photo 2 of 2 : SP\_2017\_RD2089\_316\_5\_20170407\_00006.jpg

Close view of the site.

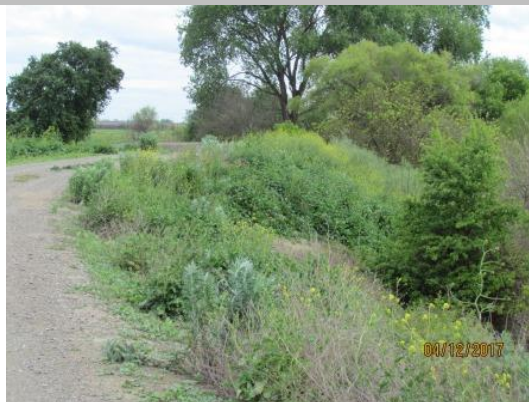
Photo 1 of 2 : SP\_2017\_RD2089\_316\_29\_20170417\_00053.jpg

View of the tall vegetation on the levee slope.

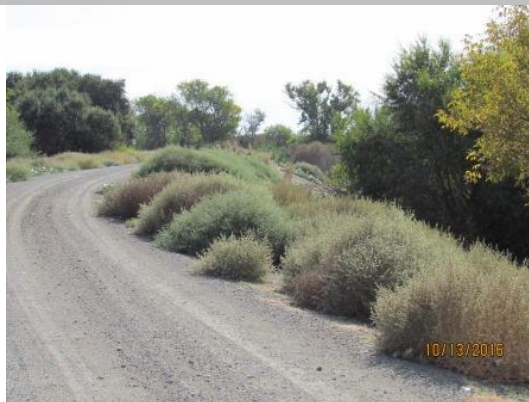
Photo 2 of 2 : SP\_2017\_RD2089\_316\_29\_20170407\_00021.jpg

LM Start	<b>0.50</b>	Rating **	U	Issue No.	<b>29 (cont)</b>
LM End	<b>0.71</b>	Issue Type +	Ma	Location *	WS

View of the vegetation on the waterside levee slope.

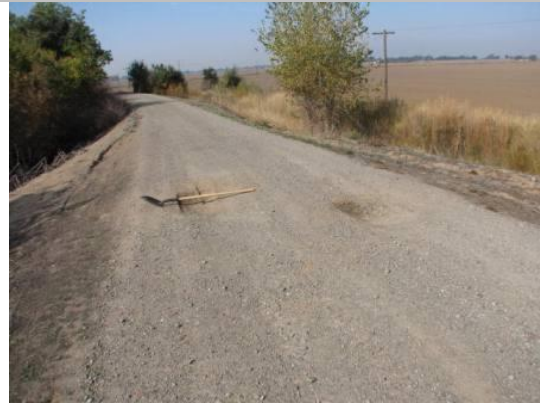
Photo 1 of 1 : SP\_2017\_RD2089\_316\_14\_20170407\_00009.jpg

LM Start	0.54	Rating **	M	Issue No.	14
LM End	0.54	Issue Type +	Ma	Location *	CR
Category	Earthen Levee			GPS Latitude/Longitude	
				Start	End
Item	Crown Surface / Depressions / Rutting			37.810087 °	37.810087 °
				-121.394200 °	-121.394200 °
DWR ID	DWR_RD2089_01_s_2012_14				
Comment Code					
C3 : Add appropriate gravel or road base. Grade and compact.					
Inspector Comment					
11/10/2011 Minor depressions will cause ponding.

11/10/2011 Depressions in crown.

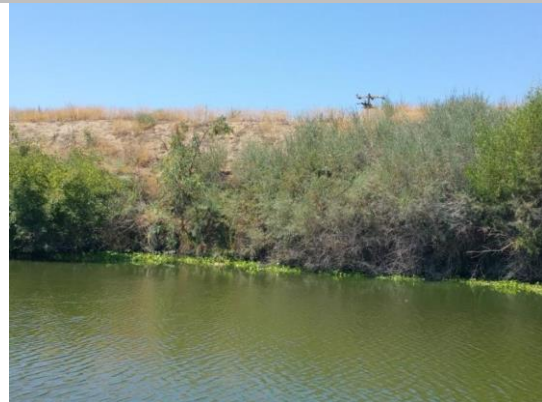
Photo 1 of 1 : SP\_2017\_RD2089\_316\_3\_20170407\_00004.jpg

LM Start	0.67	Rating **	U	Issue No.	3
LM End	0.67	Issue Type +	Ma	Location *	WS
Category	Supplemental			GPS Latitude/Longitude	
				Start	End
Item	DWR Erosion Survey			37.809780 °	37.809780 °
				-121.396230 °	-121.396230 °
DWR ID	DWR_RD2089_01_s_2017_3

Comment Code					
Inspector Comment					
07/25/2016: No significant change observed.					
06/25/2015: No significant change observed.					
07/02/2014: No significant change observed.					
08/13/2013: No significant change observed.					
08/07/2012: The site has been visited by boat survey. No significant change observed					
08/23/2011: The 5-foot vertical scarp shows no significant change from the last year inspection. No new erosion activities observed. Dense white willow trees on site.					
09/07/2010: It was difficult to view the erosion due to the thick Willow thickets and other vegetation at the water line. At the time of the inspection, there were no signs of repair on site. As noted during the last survey, there is a 5-foot vertical scarp along the lower slope that may be subjected to high flow velocities.					
08/05/2010: Recommended for repair, per CLRO; "Erosion of this site may be subjective to rapid rates of erosion."

09/28/2009: No major change observed; 5-foot vertical scarp is immediately downstream of where berm has tapered; site is recommended as local maintenance issue, per CLRO CES Evaluation 2008 Report; Site # is the same as RM29.6, LM0.60; previously rated "U".					
11/05/2008: No change observed; rodent holes on lower slope; wide levee crown. [2016 Site ID:RD2089U01RM29.61]

Front view of the site. Note the very dense white willow thickets on site.

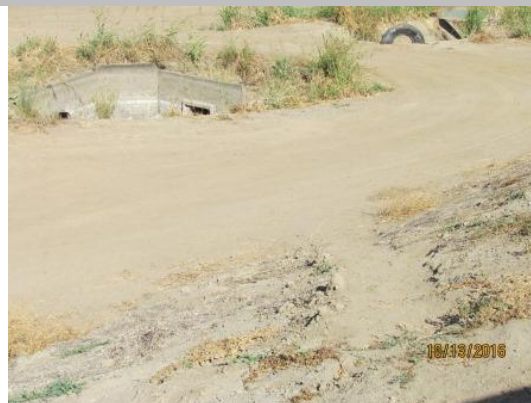
Photo 1 of 1 : SP\_2017\_RD2089\_316\_22\_20170407\_00016.jpg

LM Start	0.80	Rating **	M	Issue No.	22
LM End	0.80	Issue Type +	Ma	Location *	LS
Category	Earthen Levee			GPS Latitude/Longitude	
				Start	End
Item	Slope Stability			37.808466 °	37.808466 °
				-121.397847 °	-121.397847 °
DWR ID	DWR_RD2089_01_f_2016_22				
Comment Code					
S2 : Repair the levee slope damaged by foot traffic and prevent access where possible.					
Inspector Comment

View of the footpath on the landside levee slope.

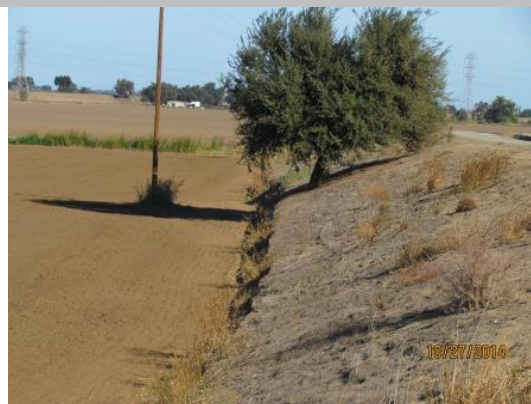
Photo 1 of 1 : SP\_2017\_RD2089\_316\_17\_20170407\_00011.jpg

LM Start	0.81	Rating **	M	Issue No.	17
LM End	0.94	Issue Type +	Ma	Location *	LS
Category	Earthen Levee			GPS Latitude/Longitude	
				Start	End
Item	Slope Stability			37.808319 °	37.806453 °
				-121.397881 °	-121.397755 °
DWR ID	DWR_RD2089_01_f_2014_17				
Comment Code					
S1 : Repair slope instability.					
Inspector Comment					
Landside levee toe cut due to farming.

View of the vertical cut along the landside levee toe.

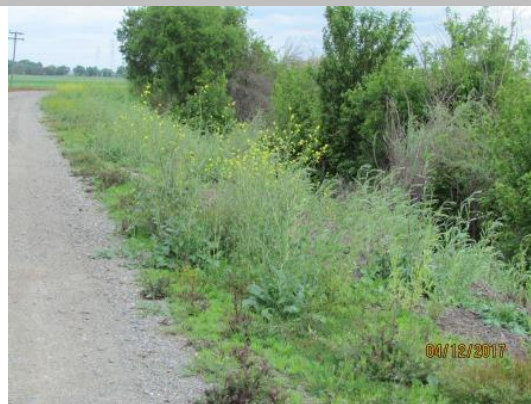
Photo 1 of 2 : SP\_2017\_RD2089\_316\_21\_20170417\_00052.jpg

The willows are starting to creep up the levee slope.

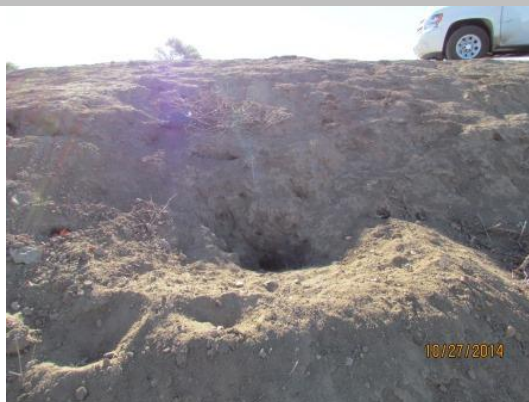
Photo 1 of 1 : SP\_2017\_RD2089\_316\_16\_20170407\_00010.jpg

View of the rodent burrow on the landside levee slope.

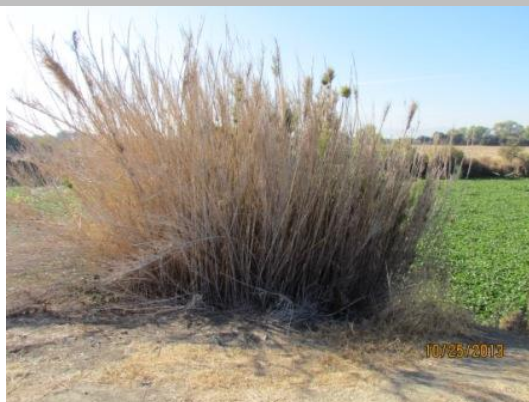
Photo 1 of 1 : SP\_2017\_RD2089\_316\_25\_20170407\_00017.jpg

View of the Arundo on the waterside slope obstructing visibility. LMA is actively trying to remove the wild growth.

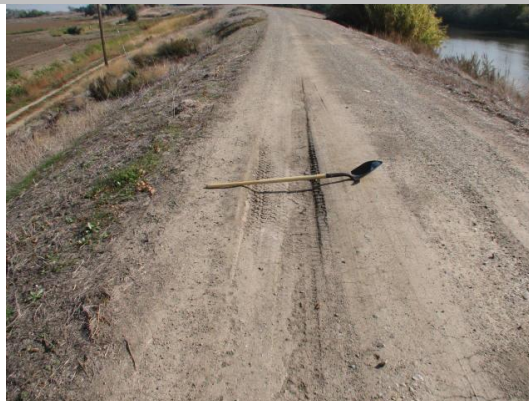
Photo 1 of 1 : SP\_2017\_RD2089\_316\_43\_20170407\_00024.jpg

11/10/2011 Depression in roadway.

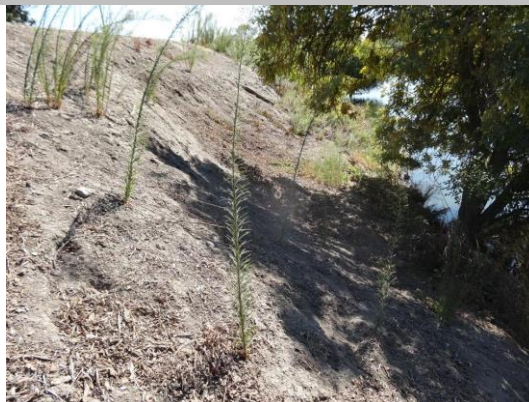
Photo 1 of 2 : SP\_2017\_RD2089\_316\_2\_20170407\_00002.jpg

LM Start	1.23	Rating **	M	Issue No.	2
LM End	1.24	Issue Type +	Ma	Location *	WS
Category	Supplemental			GPS Latitude/Longitude	
				Start	End
Item	DWR Erosion Survey			37.805580 °	37.805580 °
				-121.403010 °	-121.403010 °
DWR ID	DWR_RD2089_01_s_2017_2				
Comment Code					
Inspector Comment					
09/16/2016: The river was not navigable near the site due to the dense water grass, so the site was visited by land survey. No significant change observed.					
06/25/2015: No significant change observed.					
07/02/2014: No significant change observed.					
08/13/2013: The erosion is around a tree at the levee toe. Dense vegetation is visible. [2016 Site ID:RD2089U01RM29.04]

View of the erosion from levee slope.

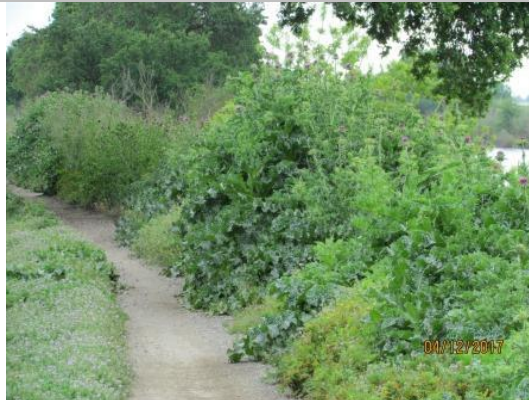
Photo 1 of 1 : SP\_2017\_RD2089\_316\_31\_20170417\_00049.jpg

View of the tall vegetation on the levee slope.

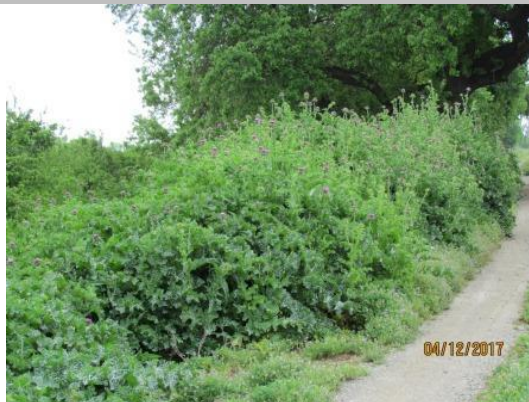
Photo 1 of 1 : SP\_2017\_RD2089\_316\_18\_20170417\_00050.jpg

View of the tall vegetation on the levee slope.

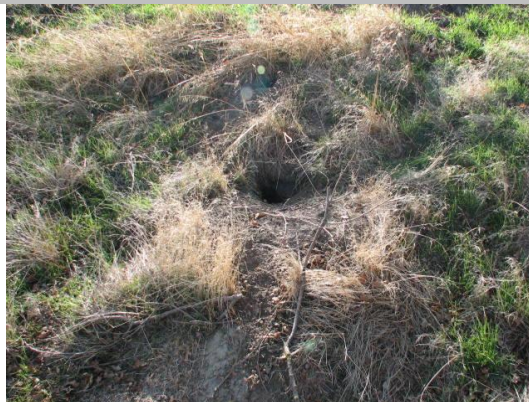
Photo 1 of 1 : SP\_2017\_RD2089\_316\_47\_20170407\_00028.jpg

11/10/2011 Active rodent burrow on landside slope.

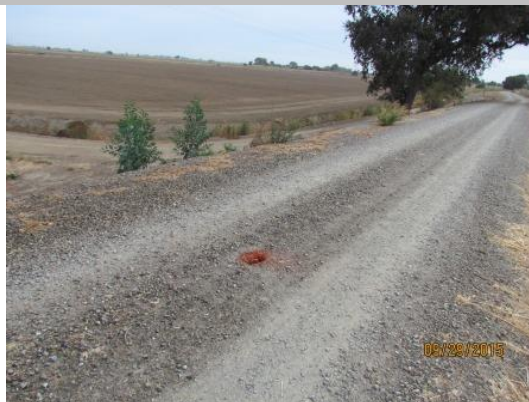
Photo 1 of 1 : SP\_2017\_RD2089\_316\_26\_20170407\_00018.jpg

View of the rodent hole on the levee crown.

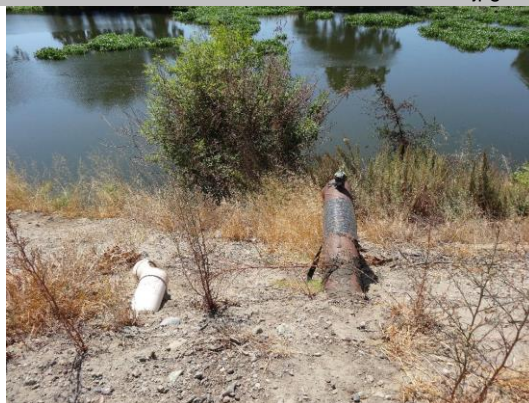
Photo 1 of 3 : UCIP\_SP\_2017\_21585\_36624.jpg

FS\_ID:21585  
DS\_ID:23045  
EP\_NO: N/A  
Repair Type: Non-Urgent  
Crossing Status: Found  
UCIP Comments: - siphon breaker needs repair.  
FIELD\_STRUCT\_DESC: 10-inch steel pipe through the levee, 2.4 feet below the crown. Pump in drain ditch on the landward side. Siphon breaker on the waterward shoulder.  
FS Date: 9/12/2013

WS view: exposed steel pipe on levee slope. A pvc pipe on left.

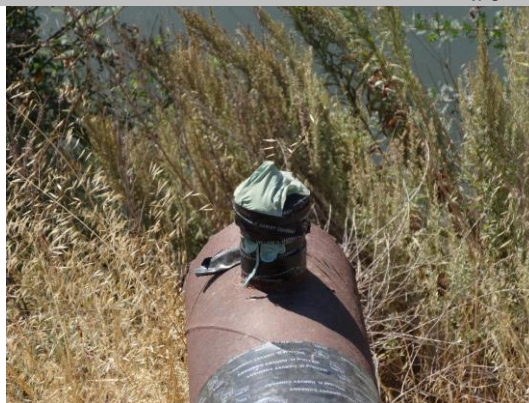
Photo 2 of 3 : UCIP\_SP\_2017\_21585\_36623.jpg

WS view: exposed steel pipe with siphon breaker. Looks siphon breaker needs repair.

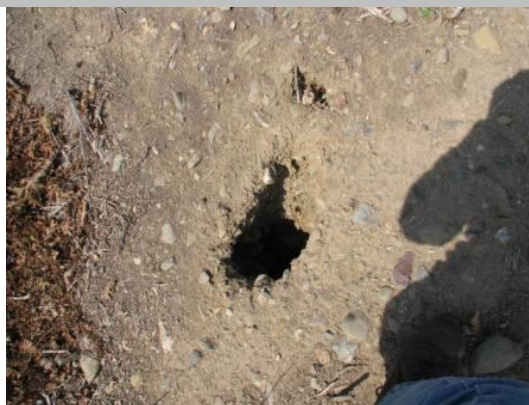
Photo 1 of 1 : SP\_2017\_RD2089\_316\_49\_20170407\_00029.jpg

11/10/2011 Deep burrow on waterside.

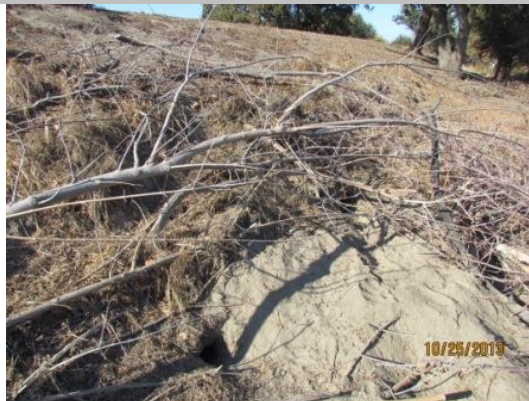
Photo 1 of 1 : SP\_2017\_RD2089\_317\_51\_20170407\_00044.jpg

View of the rodent burrow on the landside levee toe.

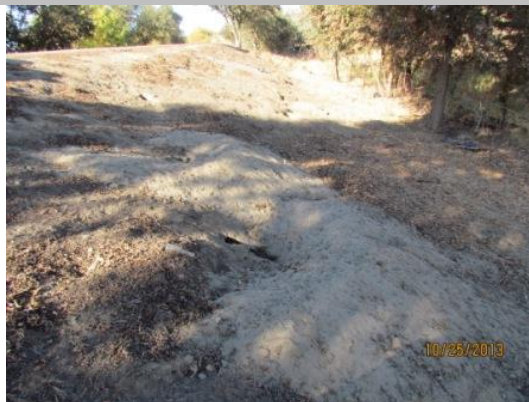
Photo 1 of 3 : SP\_2017\_RD2089\_317\_53\_20170407\_00046.jpg

LM Start	0.30	Rating **	U	Issue No.	53
LM End	0.31	Issue Type +	Ma	Location *	LS
Category	Earthen Levee			GPS Latitude/Longitude	
				Start	End
Item	Animal Control			37.809977 °	37.810022 °
				-121.411189 °	-121.411387 °
DWR ID	DWR_RD2089_02_f_2013_53				
Comment Code					
A1 : Exterminate rodents and backfill and compact or grout burrows.					
Inspector Comment					
Exterminating rodents and grouting the burrows recommended.

View of the multiple rodent burrows on the landside levee slope.

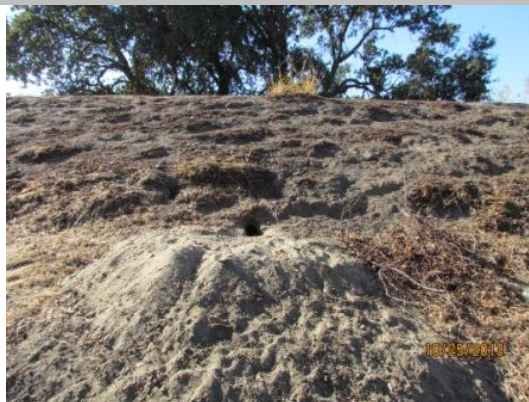
Photo 2 of 3 : SP\_2017\_RD2089\_317\_53\_20170407\_00047.jpg

View of the rodent burrow on the landside levee slope.

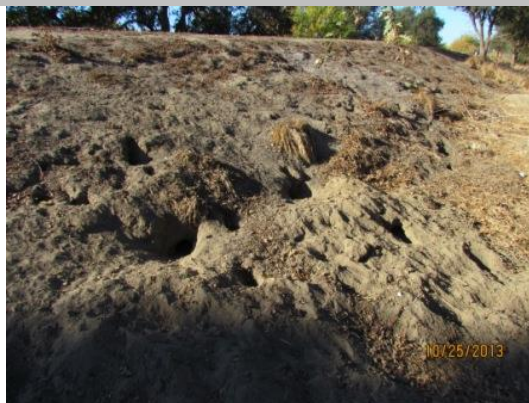
Photo 3 of 3 : SP\_2017\_RD2089\_317\_53\_20170407\_00048.jpg

LM Start	0.30	Rating **	U	Issue No.	53 (cont)	
LM End	0.31	Issue Type +	Ma	Location *	LS	
Category	Earthen Levee			GPS Latitude/Longitude		
				Start		End
Item	Animal Control			37.809977 °		37.810022 °
				-121.411189 °		-121.411387 °
DWR ID	DWR_RD2089_02_f_2013_53					
Comment Code						
A1 : Exterminate rodents and backfill and compact or grout burrows.						
Inspector Comment						
Exterminating rodents and grouting the burrows recommended.

Another view of the multiple rodent burrows on the landside levee slope.

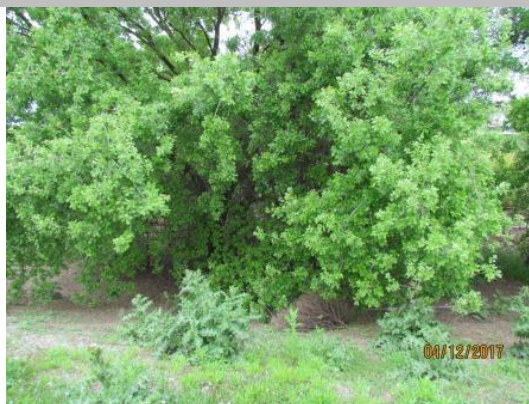
Photo 1 of 1 : SP\_2017\_RD2089\_317\_55\_20170417\_00060.jpg

View of the overgrown tree on the levee slope.

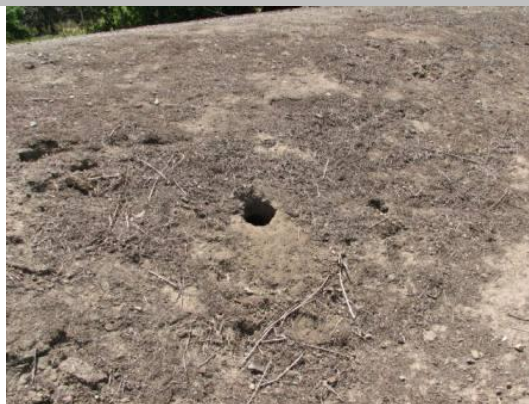
Photo 1 of 1 : SP\_2017\_RD2089\_317\_26\_20170407\_00023.jpg

LM Start	0.36	Rating **	M	Issue No.	26
LM End	0.36	Issue Type +	Ma	Location *	LS
Category	Earthen Levee			GPS Latitude/Longitude	
				Start	End
Item	Animal Control			37.810125 °	37.810125 °
				-121.412317 °	-121.412317 °
DWR ID	DWR_RD2089_02_s_2012_26				
Comment Code					
A3 : No rodents visible, but rodent burrows visible; need to backfill and compact or grout burrows.					
Inspector Comment					
Active burrow needs to be repaired.

05/24/2011 Active rodent burrow.

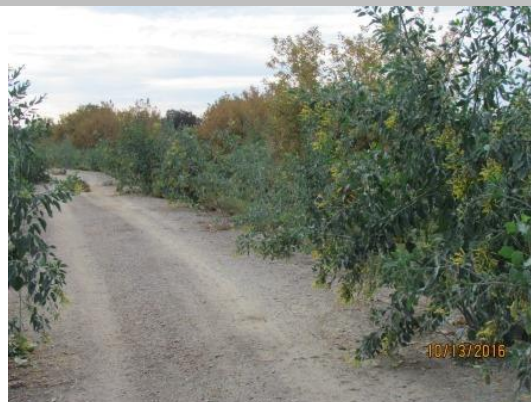
Photo 1 of 1 : SP\_2017\_RD2089\_317\_44\_20170407\_00041.jpg

View of the vegetation on the levee slopes.

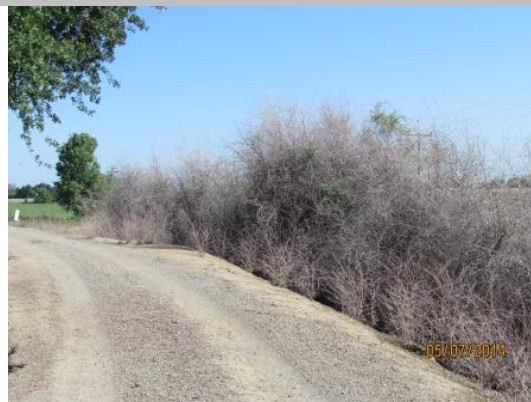
Photo 1 of 2 : SP\_2017\_RD2089\_317\_36\_20170407\_00031.jpg

Extremely thick dead brush prevents access and visibility.

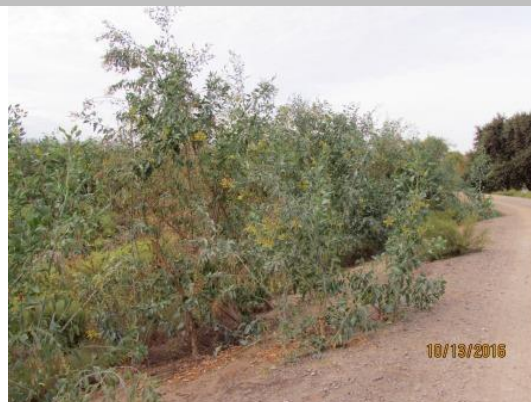
Photo 2 of 2 : SP\_2017\_RD2089\_317\_36\_20170407\_00032.jpg

Another view of the thick vegetation on the landside levee slope.

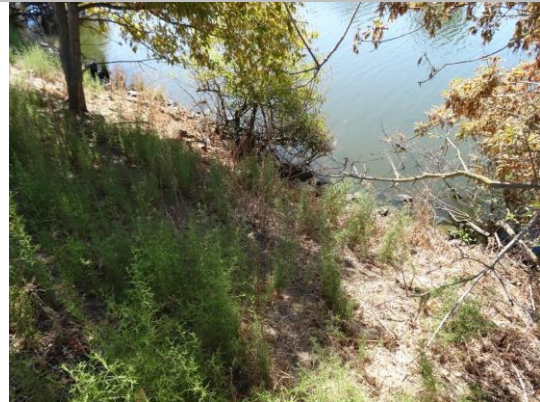
Photo 1 of 2 : SP\_2017\_RD2089\_317\_1\_20170407\_00001.jpg

09/26/2016: The erosion site was visited by land survey instead of water surface survey due to the dense water grass in the river this year. No significant change observed.  
 06/25/2015: No significant change observed.  
 07/02/2014: No significant change observed.  
 08/13/2013: No significant change observed.  
 08/07/2012: The site has been visited by boat survey. No significant change observed.  
 08/23/2011: No significant change observed on site.  
 09/07/2010: Site consists of a jutting rip rap that has created an eddy, scouring the levee slope. Most sections of the toe and lower slope are lined with rip rap. However, the rip rap is sloughing on the mid slope and at the toe, exposing the underlying soils and tree roots. The remaining revetment is no longer adequately protecting the slope. There are 3 Sycamore trees at the toe with exposed tree roots.  
 08/05/2010: Recommended for repair, per CLRO.

09/28/2009: Pocket erosion on lower slope just above the toe rip rap; protruding rip rap upstream is creating an eddy, scouring the levee slope; Site # is the same as RM28.40, LM0.30; previously rated "U"; pictures will be made available during the next survey.  
 11/05/2008: Cut into levee profile; riprap slide; rodent holes; pictures do not match GPS and current condition. [2016 Site ID:RD2089U02RM28.35]

View of the site from levee crest.

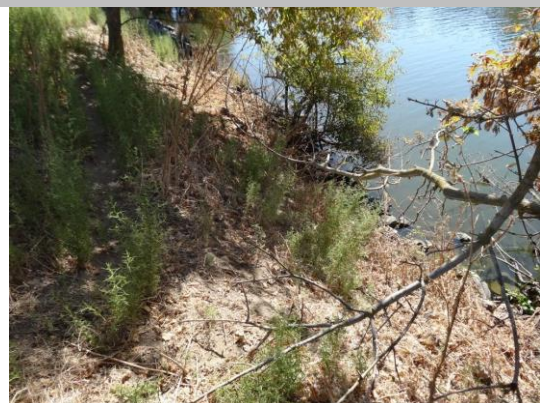
Photo 2 of 2 : SP\_2017\_RD2089\_317\_1\_20170407\_00002.jpg

Close view of the erosion. Note the vegetation at the site.

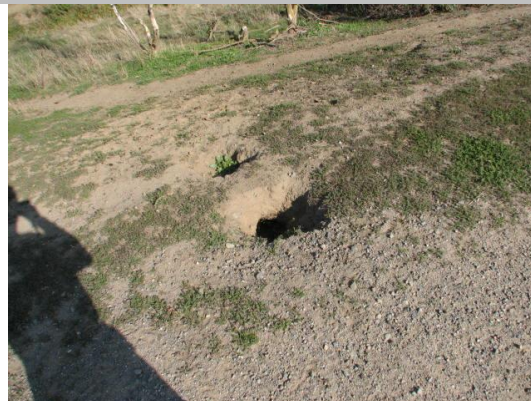
Photo 1 of 1 : SP\_2017\_RD2089\_317\_13\_20170407\_00013.jpg

11/10/2011 Two large burrows on crown, need to be filled.

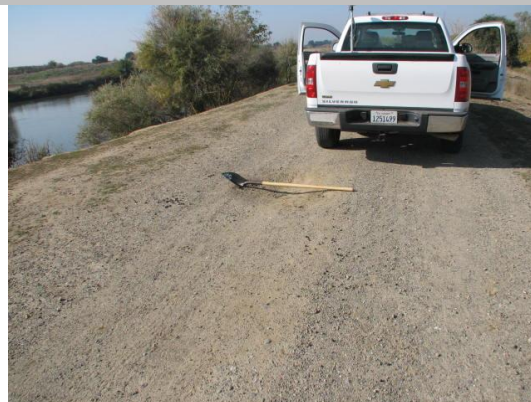
Photo 1 of 1 : SP\_2017\_RD2089\_317\_10\_20170407\_00009.jpg

11/10/2011 Depression in crown needs to be filled.

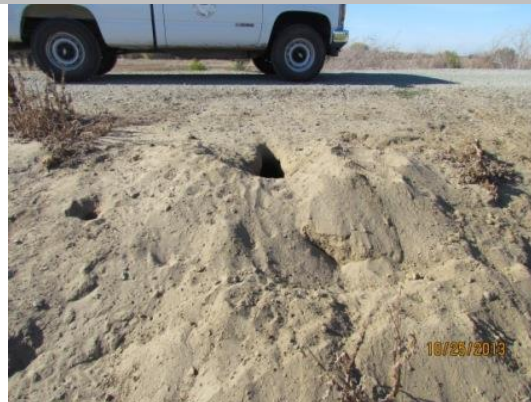
Photo 1 of 1 : SP\_2017\_RD2089\_317\_54\_20170407\_00049.jpg

View of the rodent burrow on the landside levee slope.

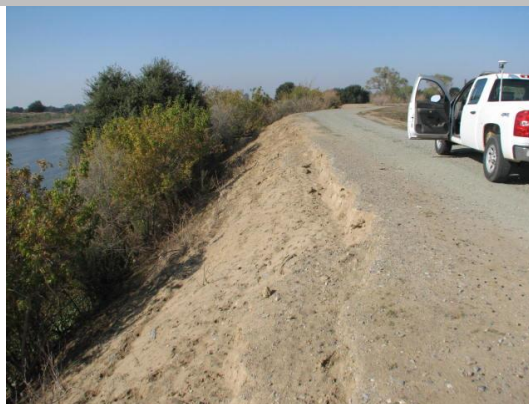
Photo 1 of 1 : SP\_2017\_RD2089\_317\_14\_20170407\_00014.jpg

11/10/2011 Approximately 1' scarp has been created by livestock travel.

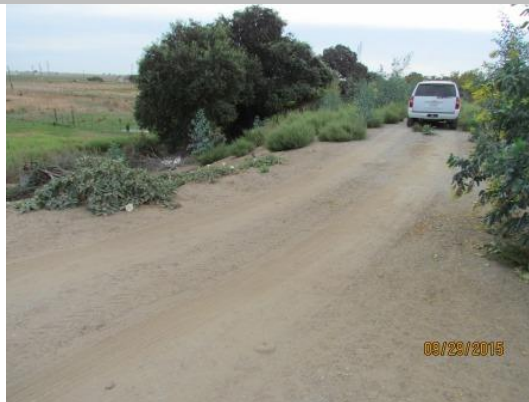
Photo 1 of 4 : SP\_2017\_RD2089\_317\_35\_20170407\_00027.jpg

View of the levee crown depression looking upstream.

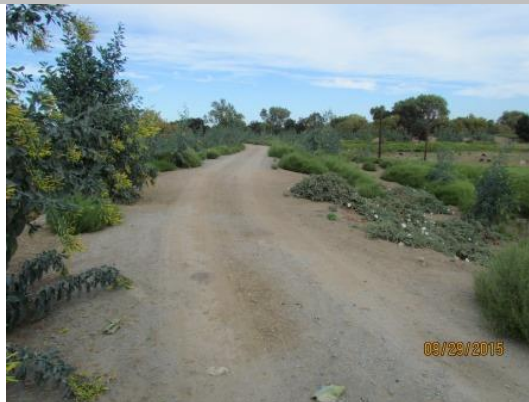
Photo 2 of 4 : SP\_2017\_RD2089\_317\_35\_20170407\_00028.jpg

View of the levee crown depression looking downstream.

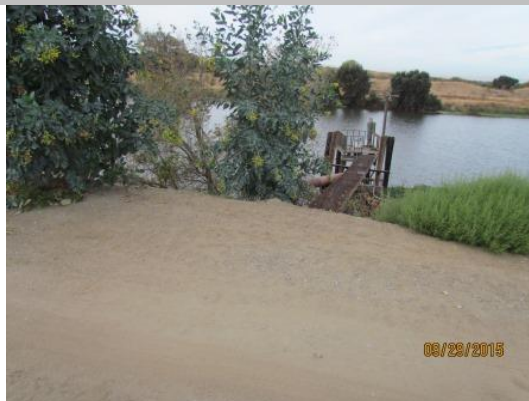
Photo 4 of 4 : SP\_2017\_RD2089\_317\_35\_20170407\_00030.jpg

View of the levee crown depression looking to the waterside.

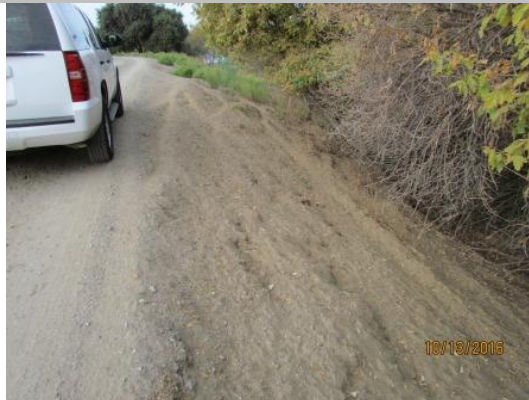
Photo 1 of 1 : SP\_2017\_RD2089\_317\_43\_20170407\_00040.jpg

View of the animal paths on the waterside levee slope.

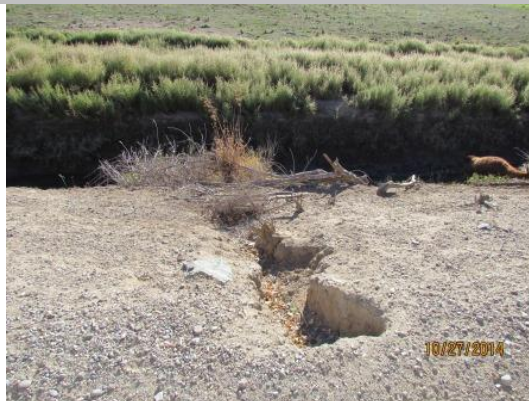
Photo 1 of 1 : SP\_2017\_RD2089\_317\_15\_20170407\_00015.jpg

View of the scour from surface runoff on the landside levee slope.

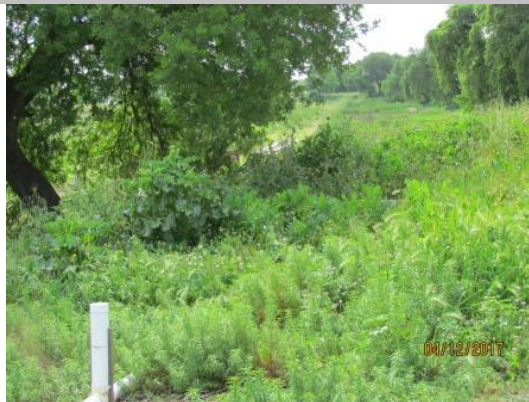
Photo 1 of 1 : SP\_2017\_RD2089\_317\_46\_20170417\_00058.jpg

View of the tall vegetation on the levee slope.

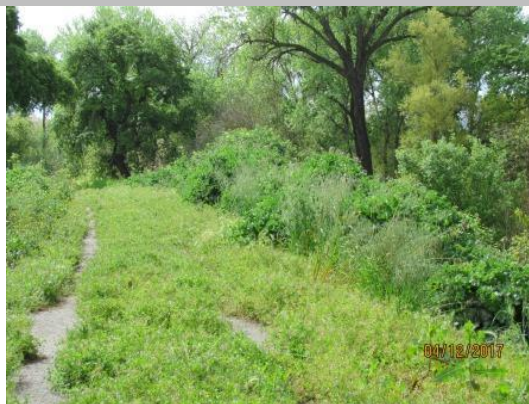
Photo 1 of 1 : SP\_2017\_RD2089\_317\_47\_20170417\_00059.jpg

View of the tall vegetation on the levee slope.

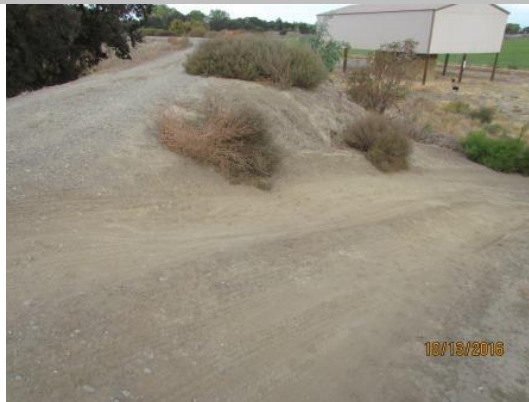
Photo 1 of 1 : SP\_2017\_RD2089\_317\_42\_20170407\_00039.jpg

View of the ramp on the landside levee slope.

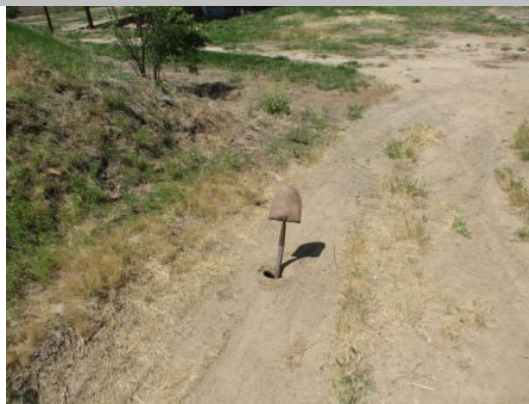
Photo 1 of 3 : SP\_2017\_RD2089\_317\_40\_20170407\_00035.jpg

05/24/2011 Deep vertical burrow in ramp on land side of levee.

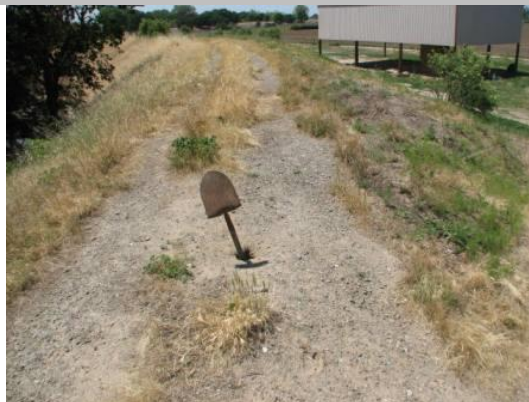
Photo 2 of 3 : SP\_2017\_RD2089\_317\_40\_20170407\_00036.jpg

05/24/2011 Deep vertical burrow in levee crown.

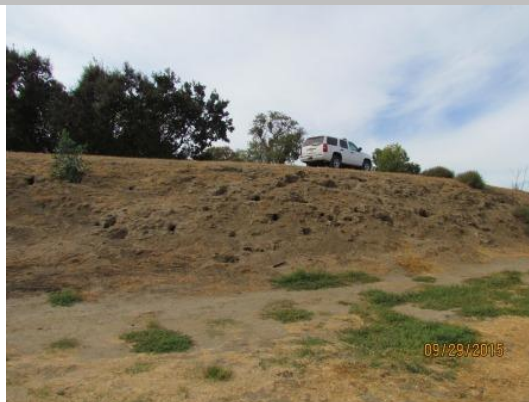
Photo 3 of 3 : SP\_2017\_RD2089\_317\_40\_20170407\_00037.jpg

View of the multiple rodent holes on the landside levee slope.

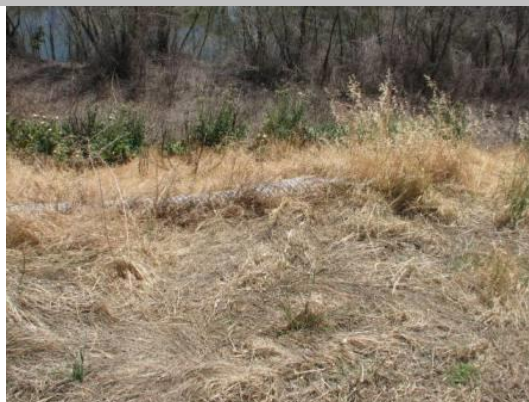
Photo 1 of 1 : SP\_2017\_RD2089\_317\_41\_20170407\_00038.jpg

05/24/2011 Old CMP left on waterside levee slope, needs to be removed.

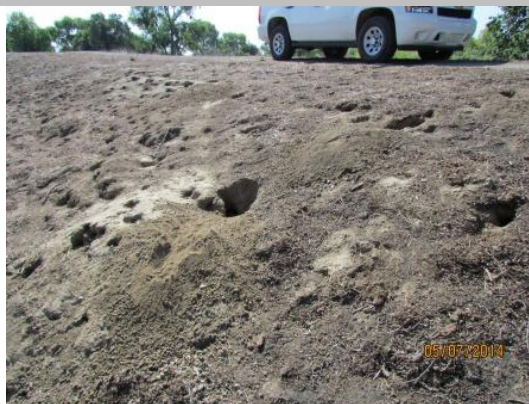
Photo 1 of 1 : SP\_2017\_RD2089\_317\_5\_20170407\_00004.jpg

View of the rodent holes on the landside levee slope.

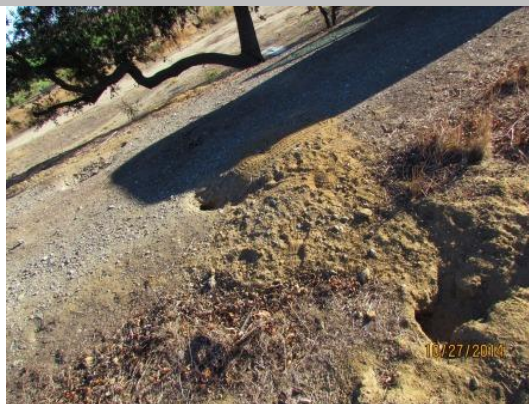
Photo 1 of 2 : SP\_2017\_RD2089\_317\_12\_20170407\_00011.jpg

View of several large rodent holes on the levee crown.

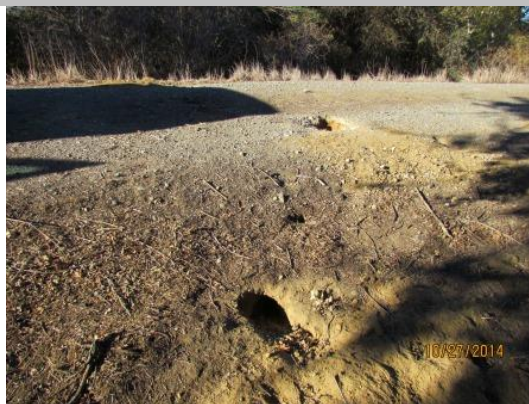
Photo 2 of 2 : SP\_2017\_RD2089\_317\_12\_20170407\_00012.jpg

View of several rodent burrows on landside levee hinge and crown.

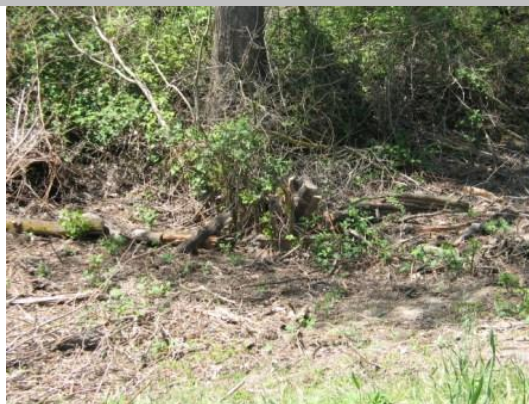
Photo 1 of 1 : SP\_2017\_RD2089\_317\_29\_20170407\_00026.jpg

Tree stump &gt;2" left after vegetation and tree removal.

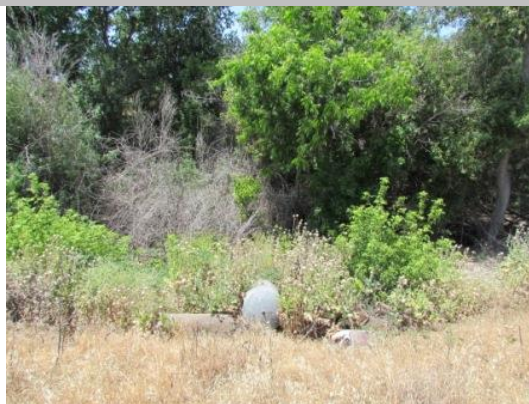
Photo 1 of 1 : SP\_2017\_RD2089\_317\_17\_20170407\_00017.jpg

View of water tanks disposed on waterside slope.

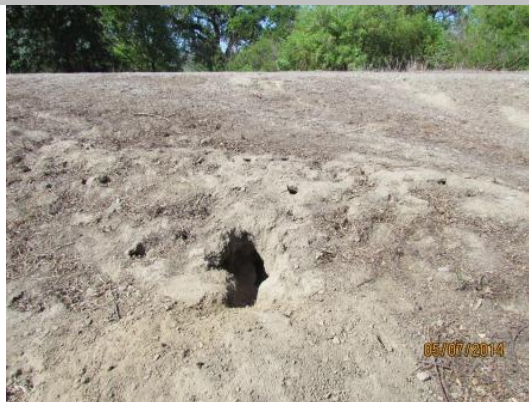
Photo 1 of 1 : SP\_2017\_RD2089\_317\_6\_20170407\_00005.jpg

View of the large rodent hole on the landside levee slope.

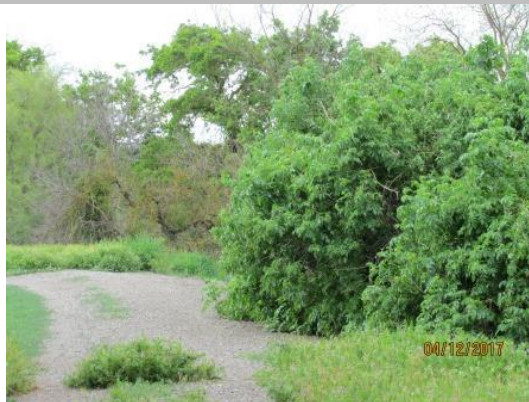
Photo 1 of 1 : SP\_2017\_RD2089\_317\_31\_20170417\_00056.jpg

View of the overgrown shrub on the levee slope.

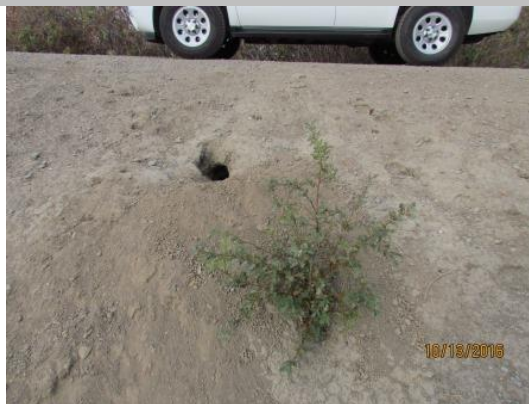
Photo 1 of 1 : SP\_2017\_RD2089\_317\_28\_20170407\_00025.jpg

View of the rodent burrow in the landside levee slope.

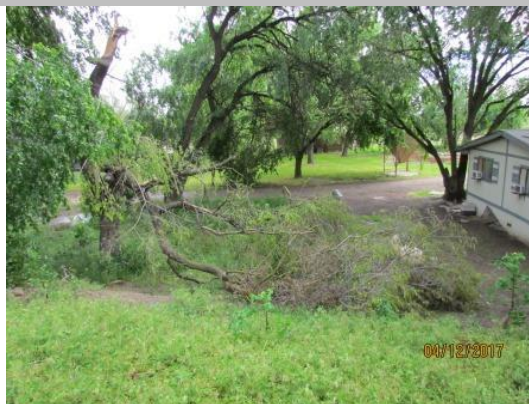
Photo 1 of 1 : SP\_2017\_RD2089\_317\_45\_20170417\_00055.jpg

View of the down tree limb on the levee slope.

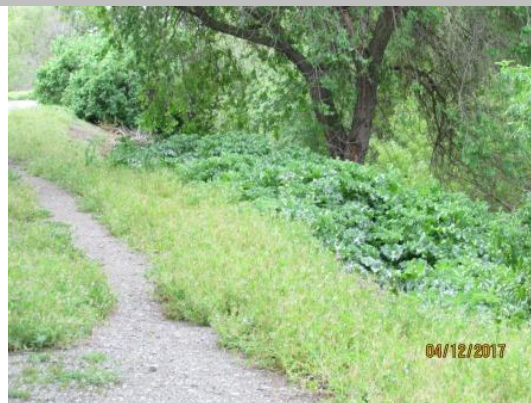
Photo 1 of 1 : SP\_2017\_RD2089\_317\_7\_20170417\_00054.jpg

View of the tall vegetation on the levee slope.

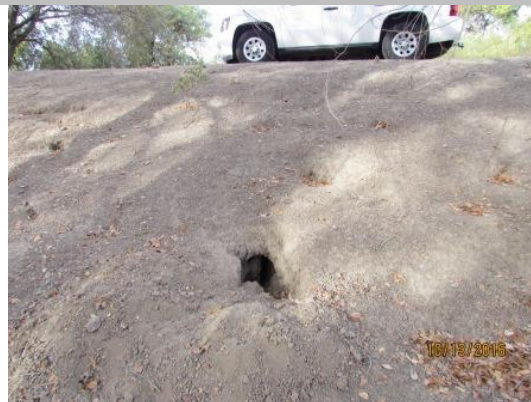
Photo 1 of 1 : SP\_2017\_RD2089\_317\_19\_20170407\_00019.jpg

View of the rodent burrow in the landside levee slope.

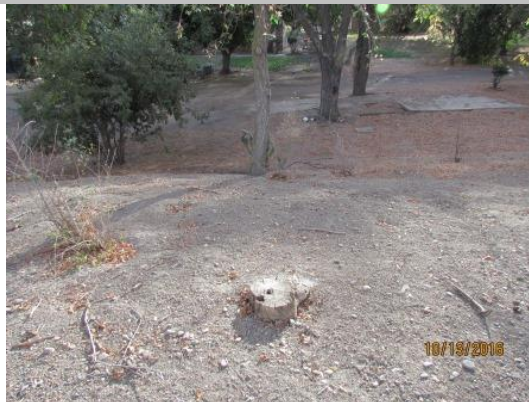
Photo 1 of 1 : SP\_2017\_RD2089\_317\_18\_20170407\_00018.jpg

View of the tree stump from the levee crown.

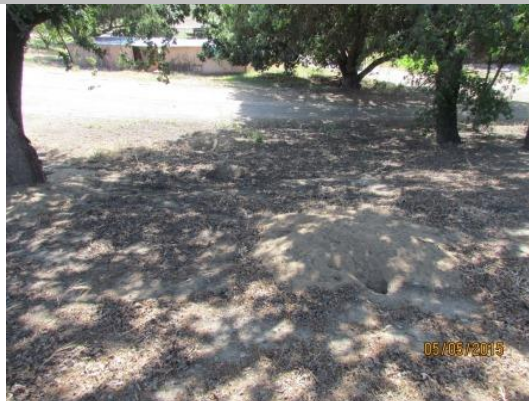
Photo 1 of 1 : SP\_2017\_RD2089\_317\_11\_20170407\_00010.jpg

View of the multiple rodent burrows on the landside levee slope.
